Information Request to SKF USA Inc.

PE02-088

Failure Analysis on specially selected Meritor THUs from the Field.

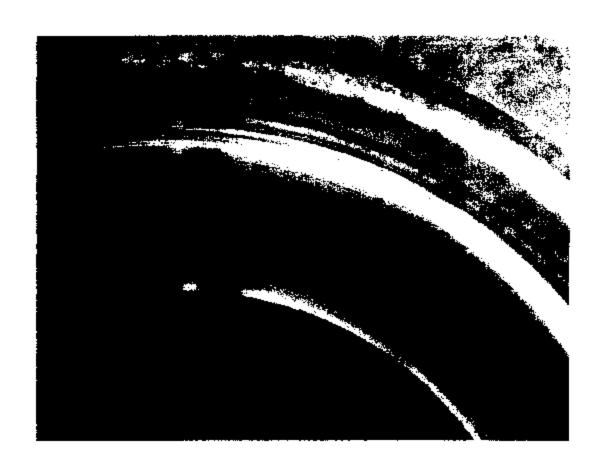
Unusual Pattern in Outer Ring Raceway

- One unit failed due to an inboard seal failure
- One unit was NTF (5/3/99 part)
- Seven units were too advanced to determine root cause
- Remaining 9 units show common issue:
 - Outer ring spalling
 - Most inboard, some outboard
 - OR raceway appearance

- Very limited outer ring data for Jan July 1999.
- No surface finish data found.
- MEF data indicates poorly honed raceways both inboard and outboard.
- On May 14 th issue with honing stone sensor corrected.
- June 1999 honing counter added to replace above sensor.

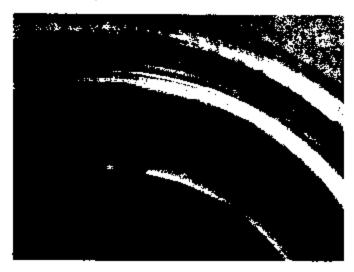
The inboard outer ring raceway shows two spails. Both outer ring raceways show patterns similar to those expected in the presence of grinding defects. The inner ring raceways are dented from overrolled particles. The inboard inner ring bore shows heavy corrosion. Corrosion and knuckle witness marks are visible on the inboard inner ring large side face.

Picture 1: Orinding defect pattern on outboard outer ring receway.

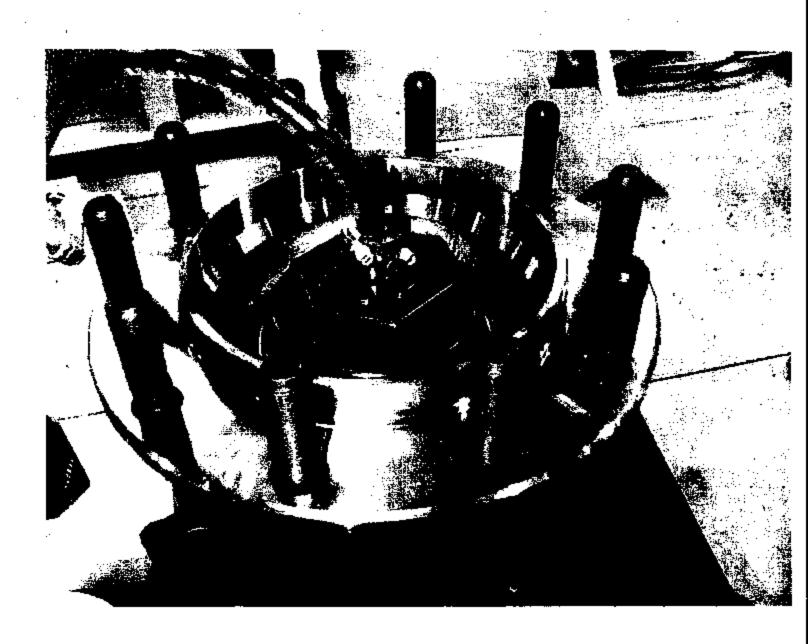
Aluminum hubcap leaking at 0.2 bar (3 psi) alum hub cap leak.jpg
